Manhole Inspection Summary

Manhole # S63K__008MH

Insp Date: **12/11/08 9:18 AM**

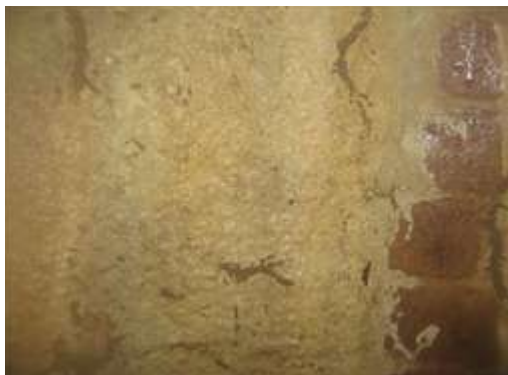
Defect 5

scum/grease on barrel wall

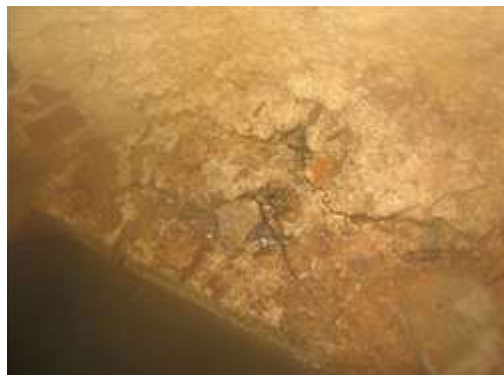
Defect 7

scum/grease/debris on bench

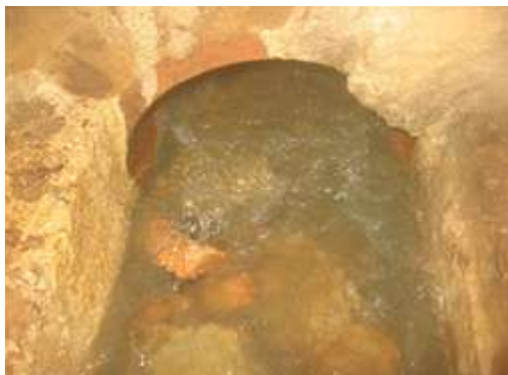
Defect 4

Debris in channel

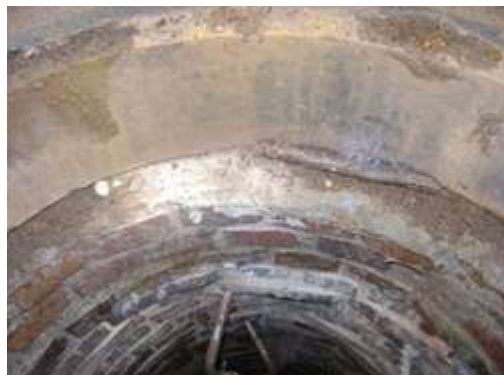
Defect 2

Frame Offset: **2** (in.) Condition: ☒ Sound ☐ Cracked ☐ Leaks

frame offset

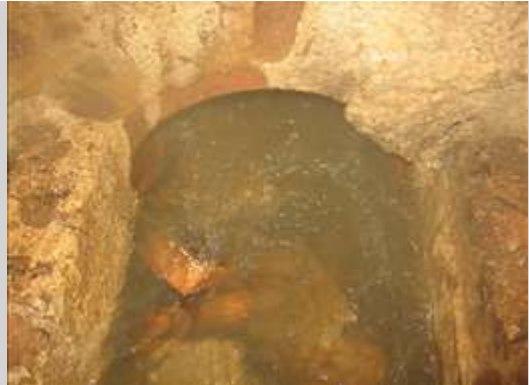
12 O'Clock Outflow

18 in. Circular Gravity Sewer
Pipe Out @ 12 O'Clock

Pipe Height: **18** (in.) Rod and Bar (Angled)
Pipe Material: **Clay** ☐ Pipe Lined
Invert Depth: **39.50** (ft.) Flow Characteristics: **None**
Deposits: ☐ None ☐ Mud ☐ Sludge ☒ **Debris** ☐ Grease
Silt Depth: **2** (in.) Deposits Extent: **Medium**
Infiltration: **None** Pipe Seal Cond: **Sound**

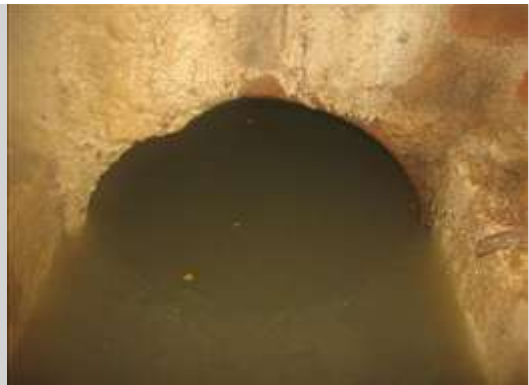
6 O'Clock Inflow

18 in. Circular Gravity Sewer
Pipe In @ 6 O'Clock

Pipe Height: **18** (in.) Rod and Bar (Angled)
Pipe Material: **Clay** ☐ Pipe Lined
Invert Depth: **39.46** (ft.) Flow Characteristics: **Slow**
Deposits: ☒ **None** ☐ Mud ☐ Sludge ☐ Debris ☐ Grease
Silt Depth: (in.) Deposits Extent:
Infiltration: **None** Pipe Seal Cond: **Sound**
